RICS
Building Survey ●●●

Property address	<input type="text" value="EXAMPLE"/>
Client's name	<input type="text" value="EXAMPLE"/>
Date of inspection	<input type="text" value="11 September 2019"/>

Surveyor's name	David Willis		
Surveyor's RICS number	5012202		
Company name	Spotlight Surveys Ltd		
Date of the inspection	11 September 2019	Report reference number	379
Related party disclosure	We confirm we have no conflicting interests with this survey report.		
Full address and postcode of the property	EXAMPLE		
Weather conditions when the inspection took place	The weather during and the day before the survey was hot and sunny following a long period of hot weather. This made damp defects difficult to detect during the survey as a general limitation.		
The status of the property when the inspection took place	The purchasers offer for the property freehold had been accepted by the vendor.

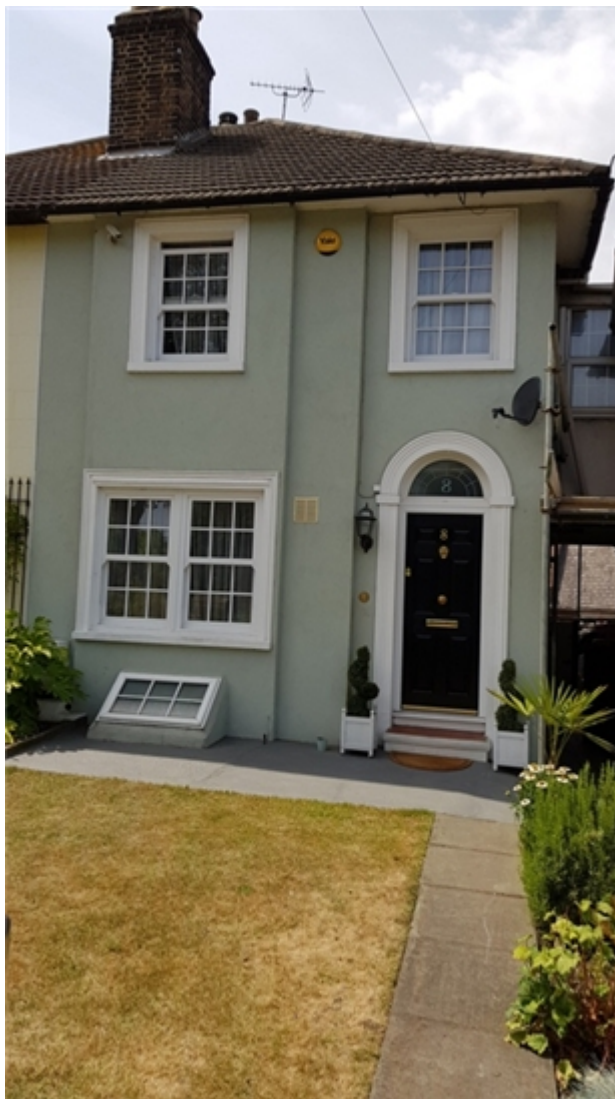
Front elevation.

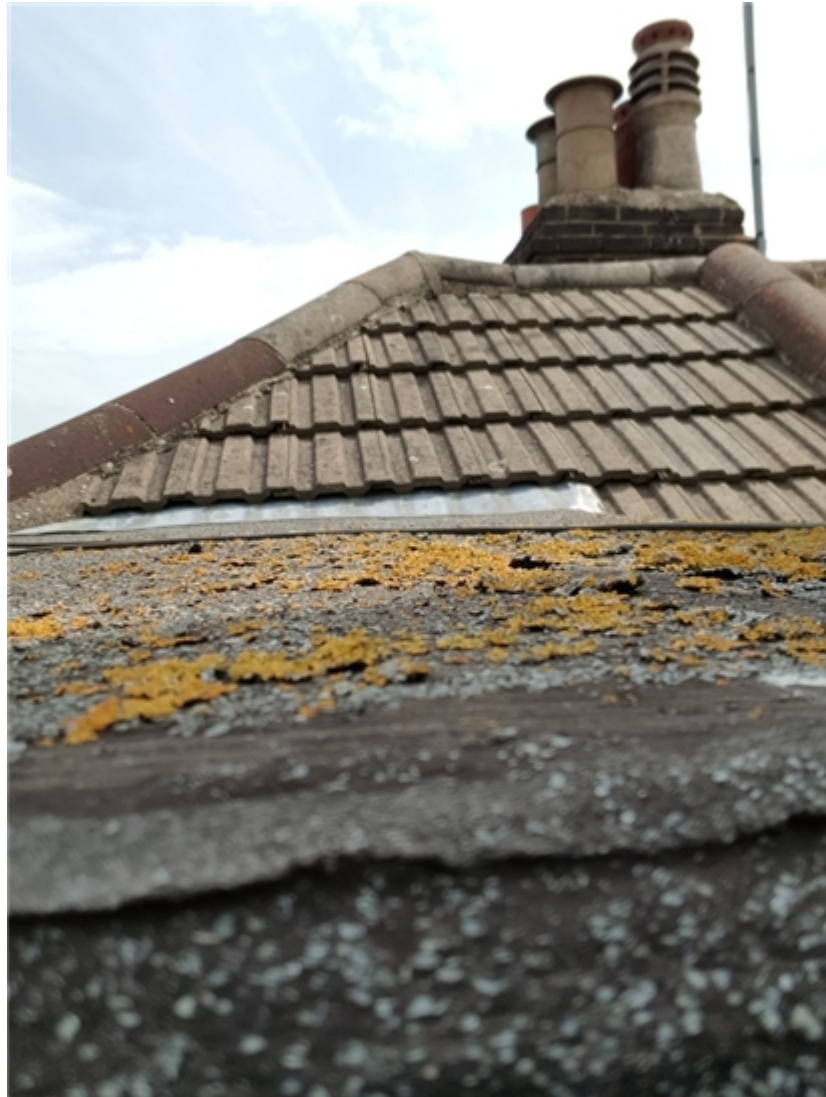
Limited inspection of roof coverings. During the survey, we were only able to see clearly the front roof pitch, therefore, the side, rear and flat roofs we could not inspect (with one exception of the rear warm deck dormer flat roof which was in poor condition commensurate with age further making us recommend that you should undertake a NI

Limited inspection of rear dormer. We used our camera phone out of the window, utilising the rear-facing camera to get a snapshot view of the rear dormer and the side of the rear chimney. This roof covering was in a significantly poor condition, having blistered patches and lifting joints (although we did not note any signs of water ingress in this area). This would need to be confirmed with the pole inspection camera however it is likely that this covering will need to be replaced in the short to medium term (approximately 2 years). This will be a significant cost as it will include scaffold access, allowance for removing the existing roof covering, the substrate and a provisional sum for any timber repairs. **NI**

Limited flat roof covering inspection.

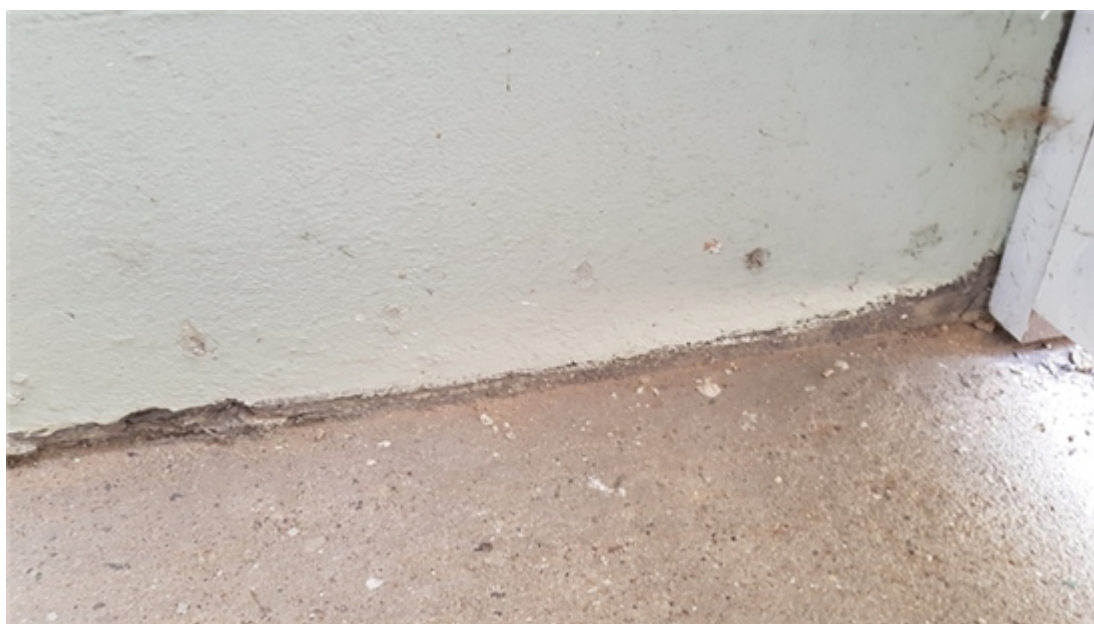
Lack of damp proof course. A property of this age would not have a suitable damp proof course, which is to be expected. There is evidence of a chemical injection damp proof course, we would recommend is that this is obtained from the conveyancer, however as there are many sections below ground especially which require tanking this is of a lesser significance. We didn't see any evidence of damage to the floor or wall structures caused by the lack of damp proof course. The tanking would be more significant as identified in section F9 which you must have a guarantee for. NI

Chemical injection damp proof course.

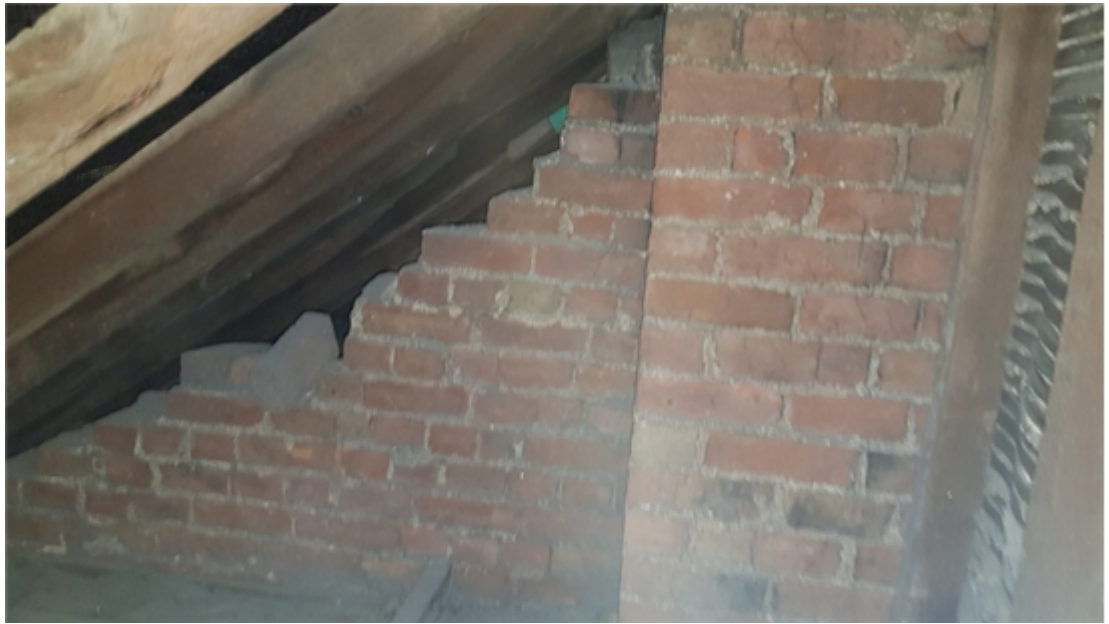
Low fire wall.

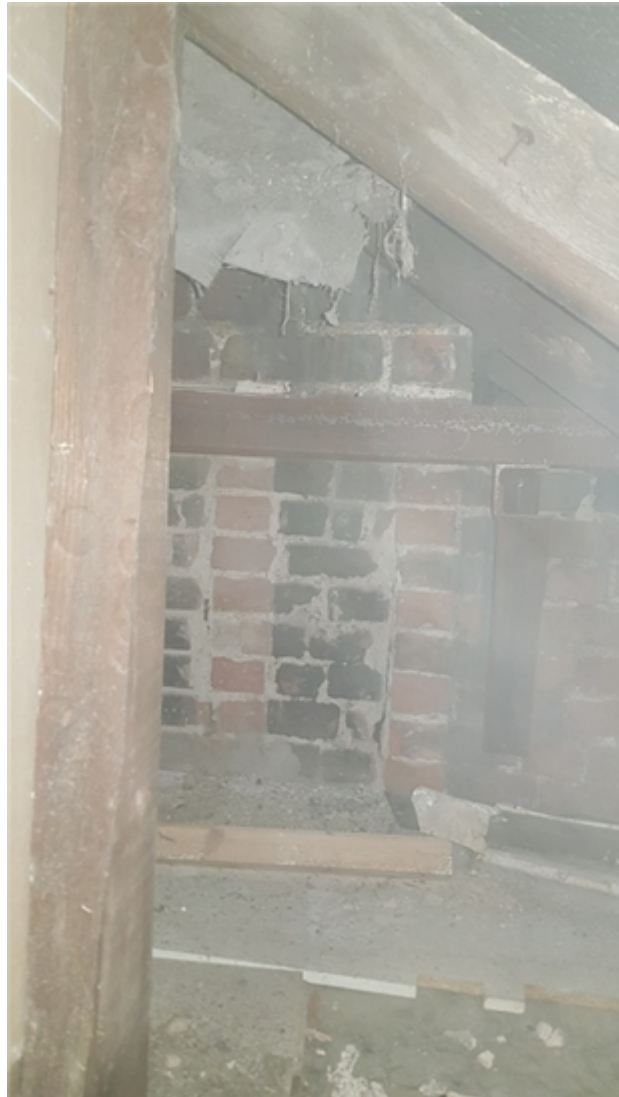
Capping off of the rear chimney. As the rear chimney has been removed, it has not been capped off , therefore, we could see daylight through the stack which means this could be a potential water ingress area. This should, therefore, be monitored in rain and then appropriately capped off if any moisture occurs.

Support for rear chimney.

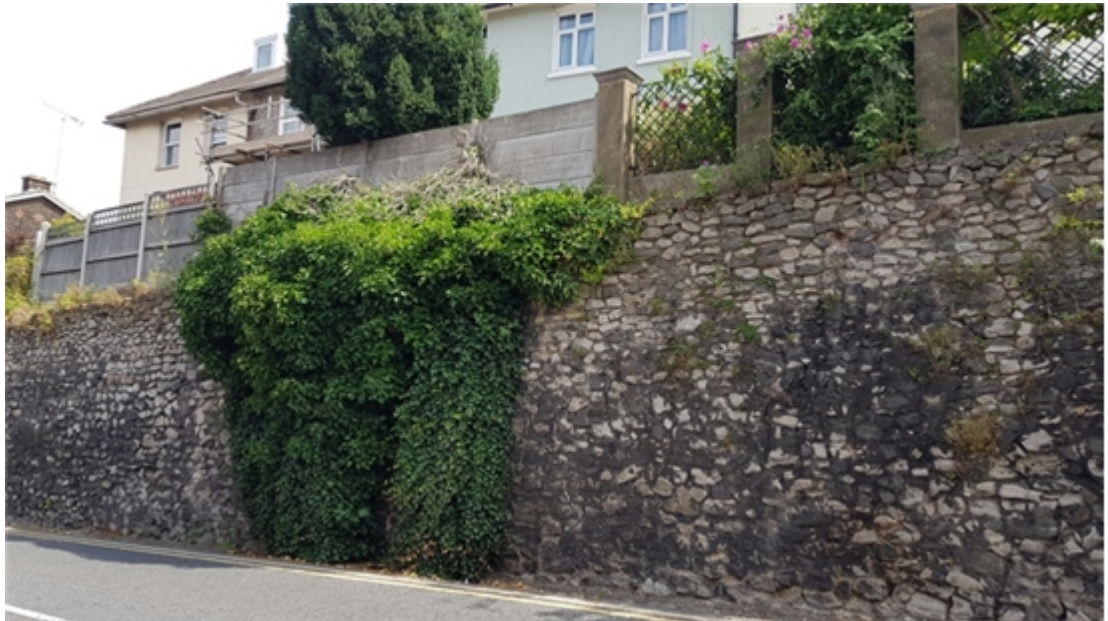
Tree removal. There is a single tree in the back garden located in close proximity to the wall, this should be heavily pruned prior to being completely removed (to reduce the risk of heave) in the short term (next 12 months).

Rear retaining wall.
